### Inspection Report

#### Minerals Regulatory Program

<b>Mine Name:</b> TME Asphalt Ridge, TME AR Lecy, and Cameron	<b>Permit Number:</b> M/047/0089, S/047/0088, and S/047/0036
<b>Operator Name:</b> TME Asphalt Ridge LLC	<b>Inspection Date:</b> April 3, 2012
<b>Inspector(s):</b> Paul Baker and Tom Munson	<b>Time:</b> About 12:30-1:30 PM
<b>Other Participants:</b> none	<b>Mine Status:</b> Inactive

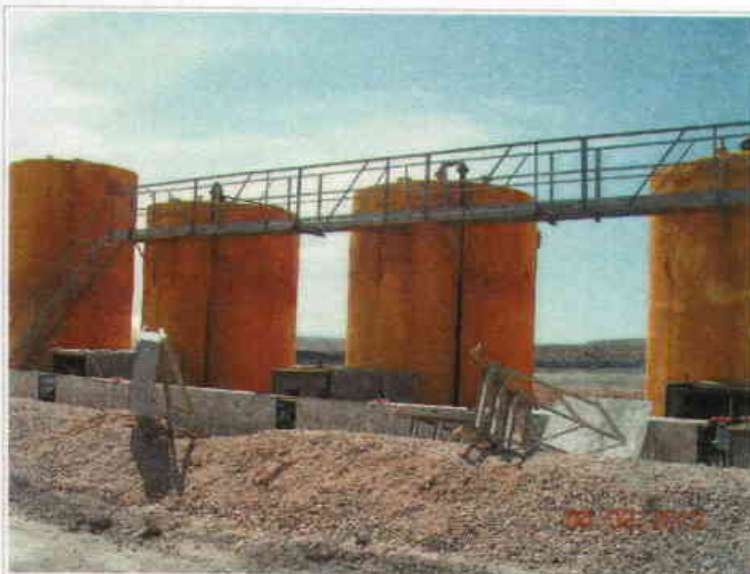
There are five large, upright tanks, one alone near the upgrader facility and four in another location (Photo 1). The one near the upgrader facility appears to be empty. Three of the other tanks appeared to be about half full, but we could not look into the fourth tank. There was no odor from any of these tanks, so we believe they may contain water.

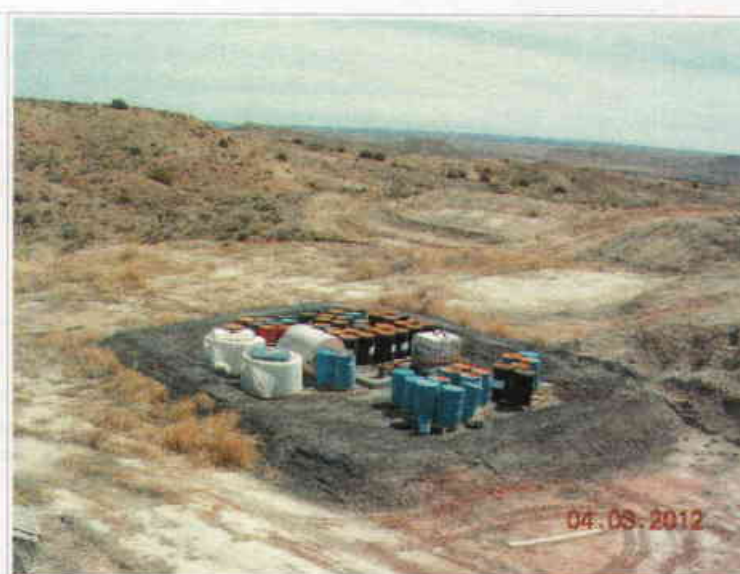
There is a large tent-type building labeled upgrader facility, and near this building there are about 50 barrels and other containers (Photo 2), mostly full, labeled tergitol, heat transfer oil, condensate, antifreeze, and 15W-40. Some of the containers were not labeled. These containers are in an open, bermed area lined with asphalt. There are also a few barrels labeled tergitol in the upgrader facility building.

As far as I have been able to determine, the barrels do not pose a particular environmental or public safety hazard at this time, but I encourage the operator to remove them before they become a problem. Since there has been vandalism, there is no guard, and since the site is fairly close yet not immediately adjacent to a public highway, it would be easy for someone to shoot at the barrels or otherwise vandalize them. They are starting to rust a little.

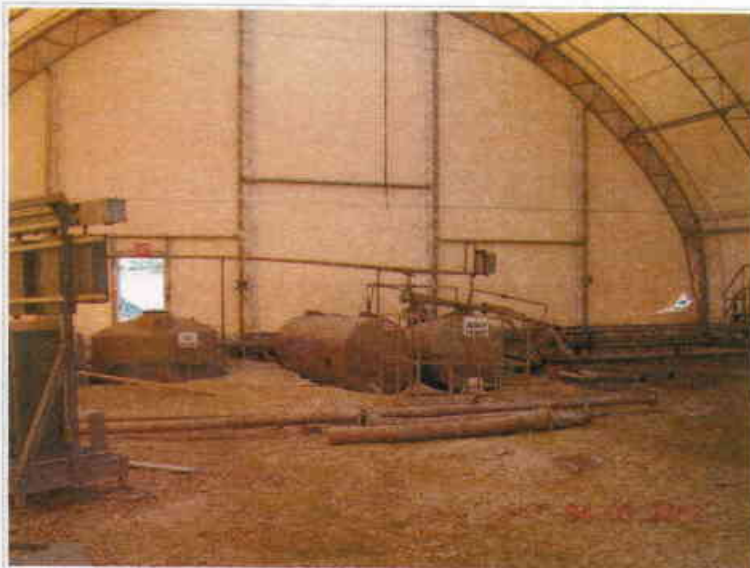
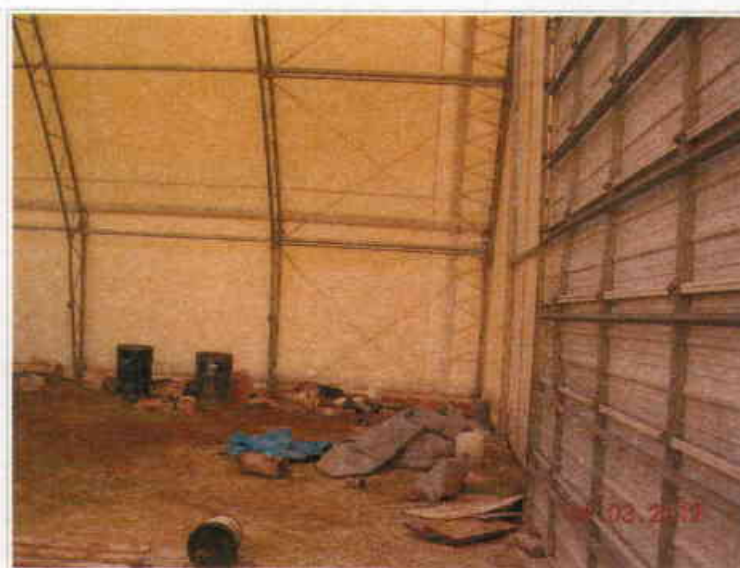
The site has the appearance of being abandoned although we could see no imminent danger to the public or the environment. Photos 3 and 4 show the interior of the upgrader facility. Much of the equipment has been vandalized (Photos 7 and 8).

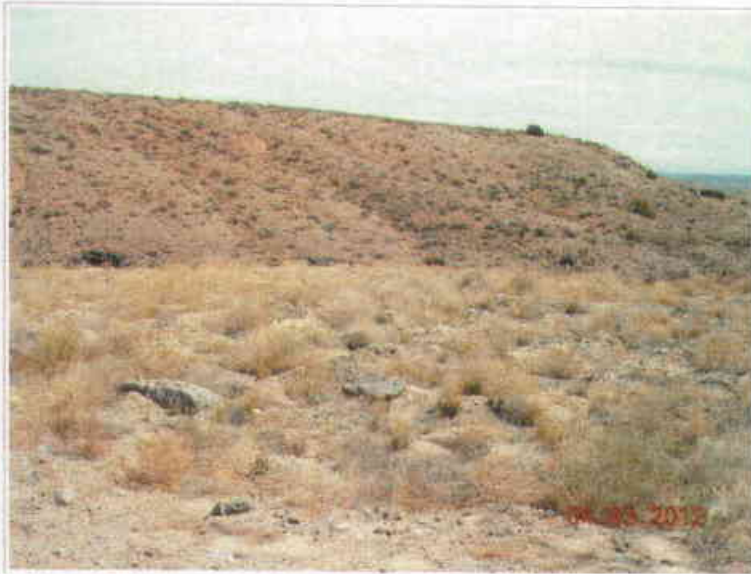
There are two areas near the stream that were deeply pocked then seeded a few years ago. One of these areas (Photo 5) has a fair amount of topsoil, and I believe it was seeded in 2007. It has excellent vegetation cover, including rabbitbrush, fourwing saltbush, and robust grasses. The other areas (Photo 6) have very little soil and little vegetation though there are few weeds. Some of the pocks have grasses (Indian ricegrass?), rabbitbrush, sagebrush, and fourwing saltbush.

I believe it is clear from the revegetation work done recently that it is vital for the operator to save and use topsoil. Material that contains largely asphalt/oil sand does not work well as a growth medium

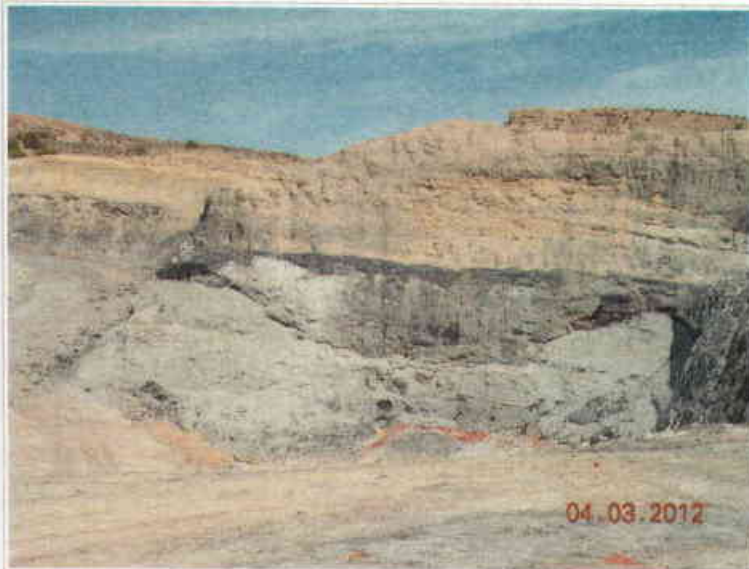
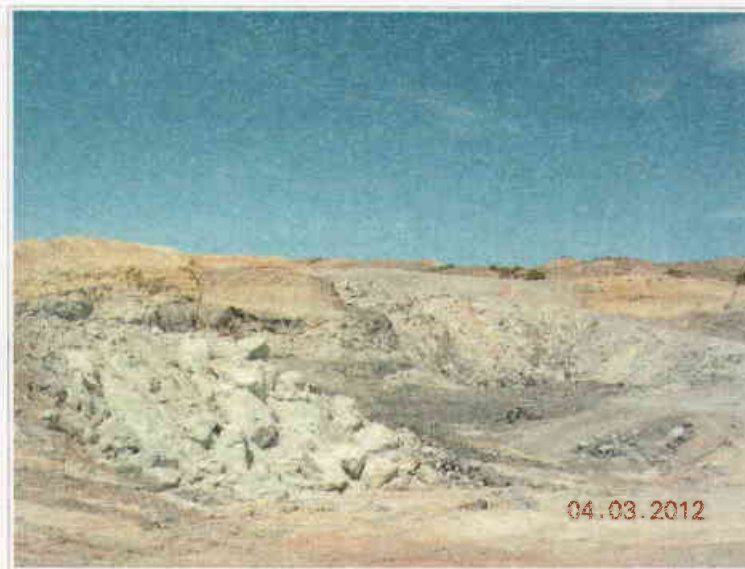
The pit is shown in Photos 9 and 10.

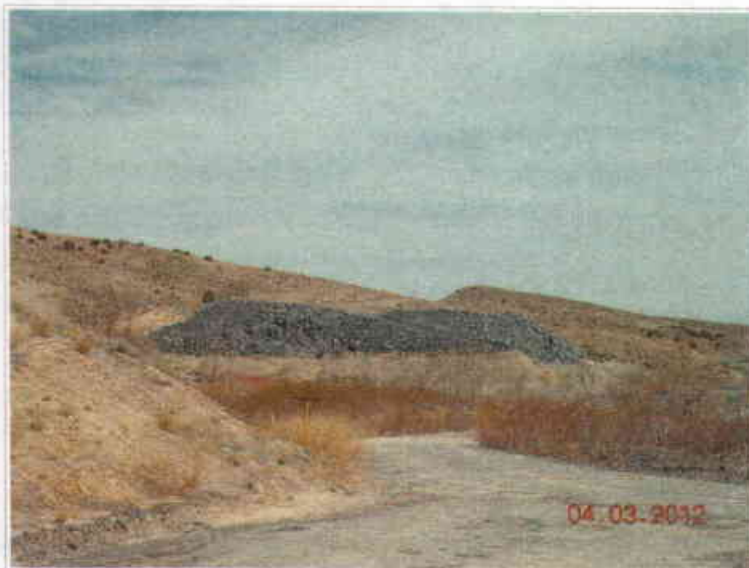
There are two large stockpiles of oil sand ore, one of which is shown in Photo 11, that are a reclamation liability.
